Case study 2: Using the geko™ device to prevent oedema and promote functional activity following foot surgery

Right scarf lateral release Akin osteotomy

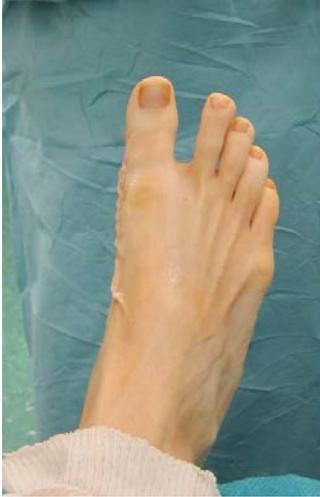
Picture 1 shows operated foot on Day 0 after the operation before the geko™ was used.

Table 2. Comparison of Day 0 and Day 7 foot after Right Scarf Akin Osteotomy procedure using geko™ device post-operatively.

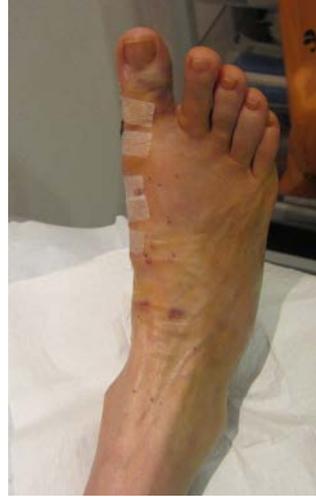
Picture 2 shows operated foot on Day 7 (note the yellow colouring is mainly due to iodine).

There was bruising as expected around the lateral and medial side of the foot (see Table 2). The wound was healing well with a lower level of bruising than expected (Picture 2). The patient had full AROM & PROM of the 1st metatarsal. Pain was limited but was tolerated by the patient. There were no reports of pins and needles and numbness in the toes
